2023 Waterwatch Site Summary Report – January 2020 – April 2023.

ME_YMR141 Merri Creek at Connolly Ave near the footbridge (De Chene Reserve, Coburg. Monitors – Merri Birdies

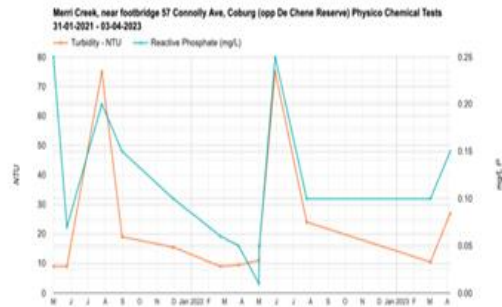
Turbidity / Reactive Phosphate

There is a pattern between a rise in **turbidity** and often a corresponding rise in **ammonia** and **reactive phosphate** readings. Possible reasons could be due to higher rainfall periods and resultant stormwater runoff. Phosphate particles bind to soil, which is a major source of high turbidity. The Merri Creek has been experiencing [high turbidity readings over recent years](#).

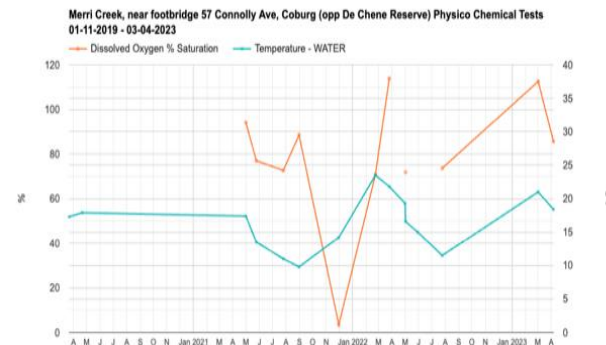
Dissolved Oxygen (DO) / Water Temperature DO had unexplained fluctuations and gaps (due to lockdowns when sampling could not be conducted) but a clear correlation between water temperature can be seen. For much of the time, DO results were above 80% during the day which indicates a healthy DO level for aquatic life. There is an excellent riffle section at the sample site which could explain this (refer to photo at right)
