**Waterbug Report for the community census sampling results on Merri Creek at Connolly Ave. Coburg**

ME\_YMR141. Merri Creek, near footbridge 57 Connolly Ave, Coburg (opp De Chene Reserve)

Date sampled: 02/04/23 at 10.00am

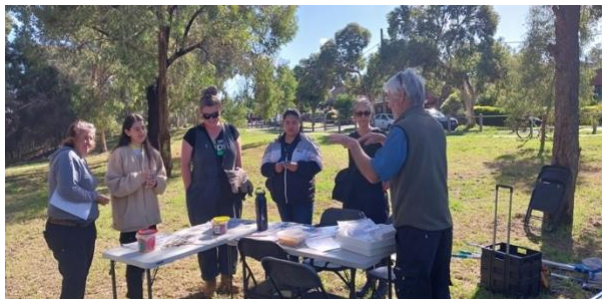
The weather was sunny and the Merri Creek appeared slightly turbid with a medium to high flow. There had been approx. 20mm of rain over the preceding 5 days. We carried out a habitat survey first to determine the variety of habitats to sample. The site was dominated by an extensive riffle with a pool upstream that had some edge vegetation trailing into the water column. Many of the habitats surveyed previously were not available due to the high water level including much of the riffle zone. There were small patches of riffle that could be safely accessed by samplers and some of the edge vegetation was also safely sampled (refer to photo above).
